Title: Production Facility Prototype Blower 1000 Hour Test Results III

Production Facility Prototype Blower 1000 Hour Test Results III

10/12/2018

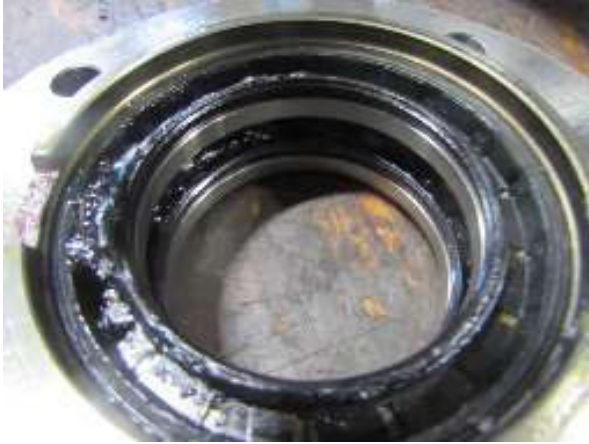
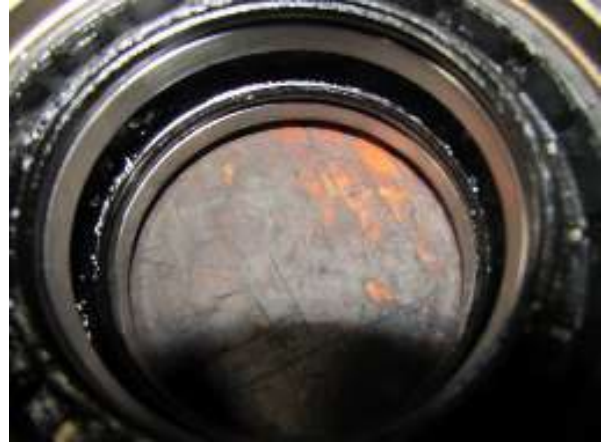
Figure 1 – Front seal showing burnt grease due to overheating

At the conclusion of the fifth 1000 hour test with helium, the pressure vessel was depressurized and opened to determine if there were any oil leaks through the blower seals. An oil leak was found near the top flange of the blower. Upon further inspection, oil was also found on the inside lobe of the blower, which could mean that the oil seal between the gearbox and blower lobe had leaked oil, as well as the O-ring on the top flange. The blower was sent to Aerzen for evaluation and repair. The blower was disassembled, cleaned and inspected. The inspection showed that the grease in the front seal appeared to have been overheated and looked burnt shown in Fig. 1. There were grooves in the rear ring retainers where the combined seals ride and have locked down in Fig. 2. There was oil getting past the ring retainers and there was grease or solidified oil inside of the combined seals shown in Fig. 3. The front cover had sludge in it in Fig. 4 and the rear sump looked normal. The blower was repaired by replacing all of the bearings and seals with new parts. Also, the tolerances were reset to factory specifications.

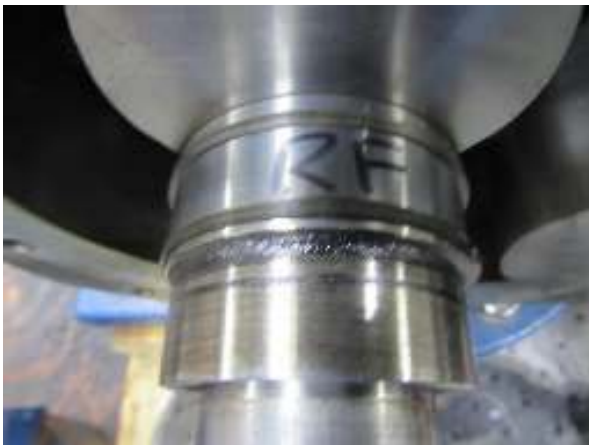
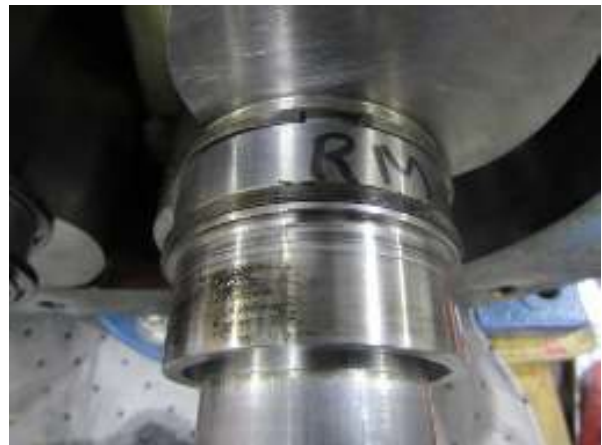
Figure 2 – Rear ring retainers showing groove from seals

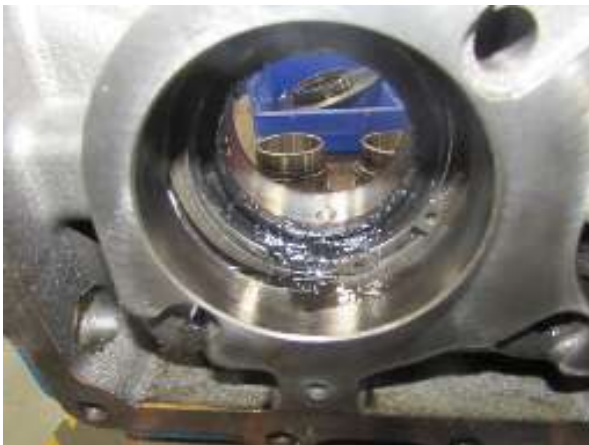
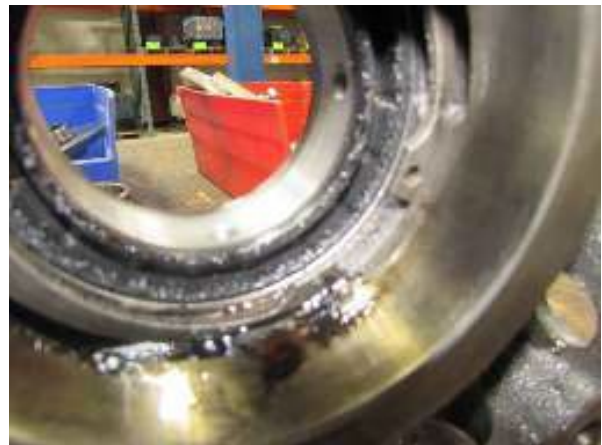
Figure 3 – Rear combined seal condition with grease or solidified oil

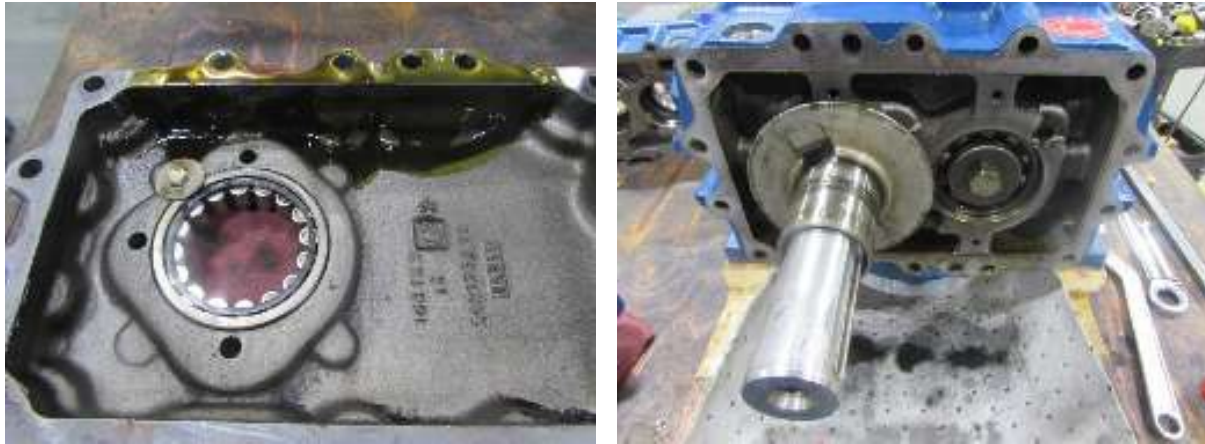
Figure 4 – Front sump cover with thick sludge (left) disassembled from blower (right).

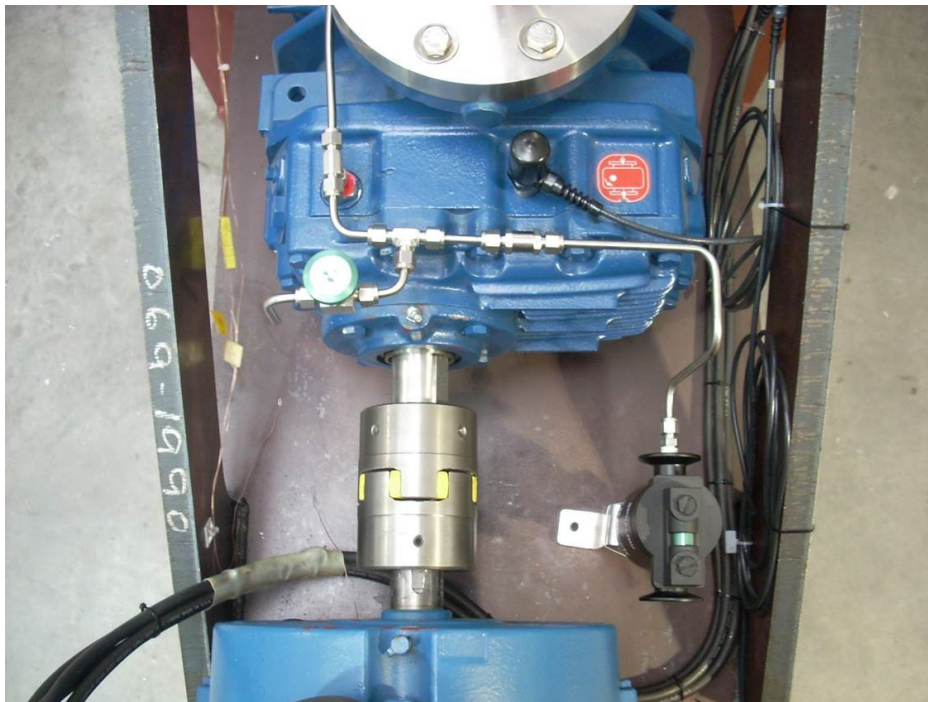
Figure 16 – Installed pressure relief system to relieve pressure from the blower gear boxes.

A pressure relief system, shown in Figs. 16-17, was designed and installed to relieve the gas pressure in the blower gearbox which occurs during high pressure helium operation, and when pressurizing and depressurizing the pressure vessel for maintenance. The oil fill plugs were connected through a check valve to a coalescing oil filter. A manual valve, normally closed, was included to allow for pressure bleed in case the check valve or filter was clogged, and pressure needed to be released to the atmosphere. This system will allow any pressure buildup in the gearbox to be released into the pressure vessel and filtered of any residual oil.

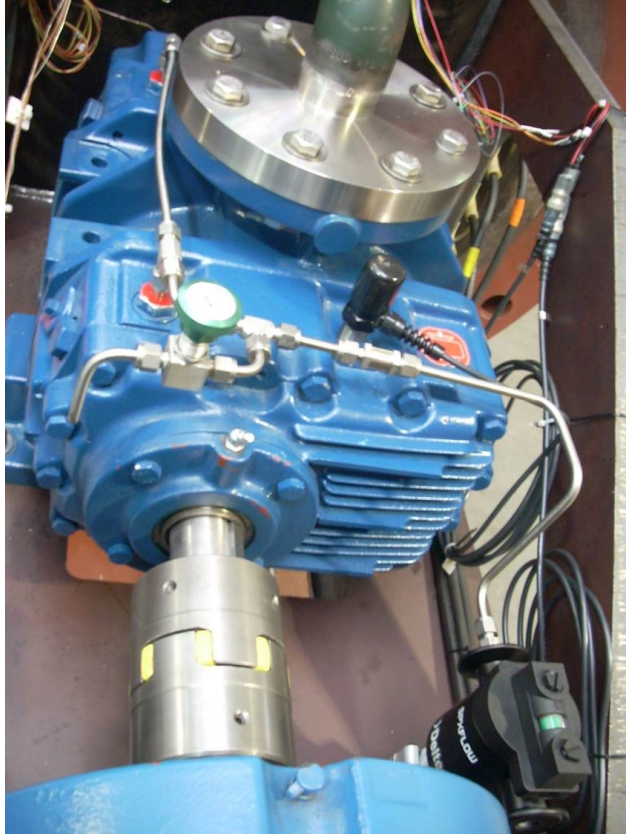
Figure 17 - Installed pressure relief system to relieve pressure from the blower gear boxes.

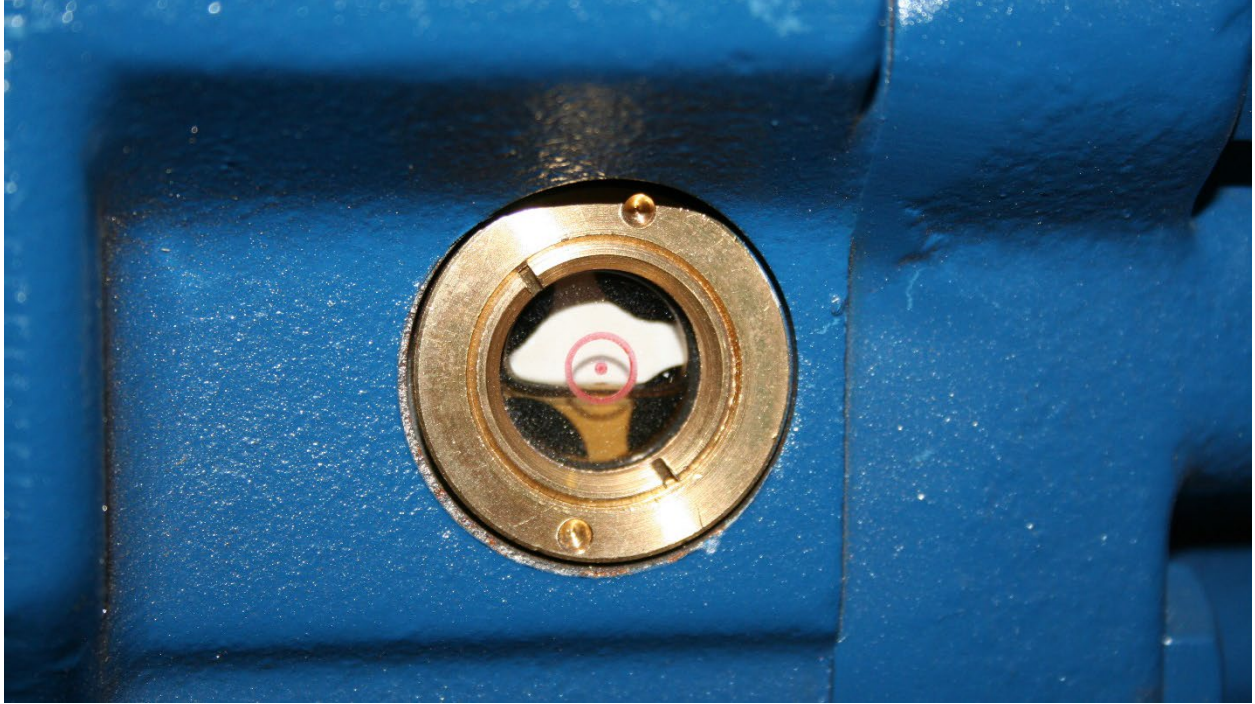
Figure 9. Oil level sight glass, showing some loss.

Upon opening the tank, some oil leakage from the shaft seal was evident. Fig 9 shows the reduced oil level in the sight glass and Figures 10 and 11 show some of the escaped oil. The oil was a thinly distributed coating over much of the interior of the tank. After investigation, it was discovered that the sealing covers had not been removed. These are vent ports that allow for pressure equalization between the oiled bearing housing and atmospheric conditions, in this case pressurized helium.

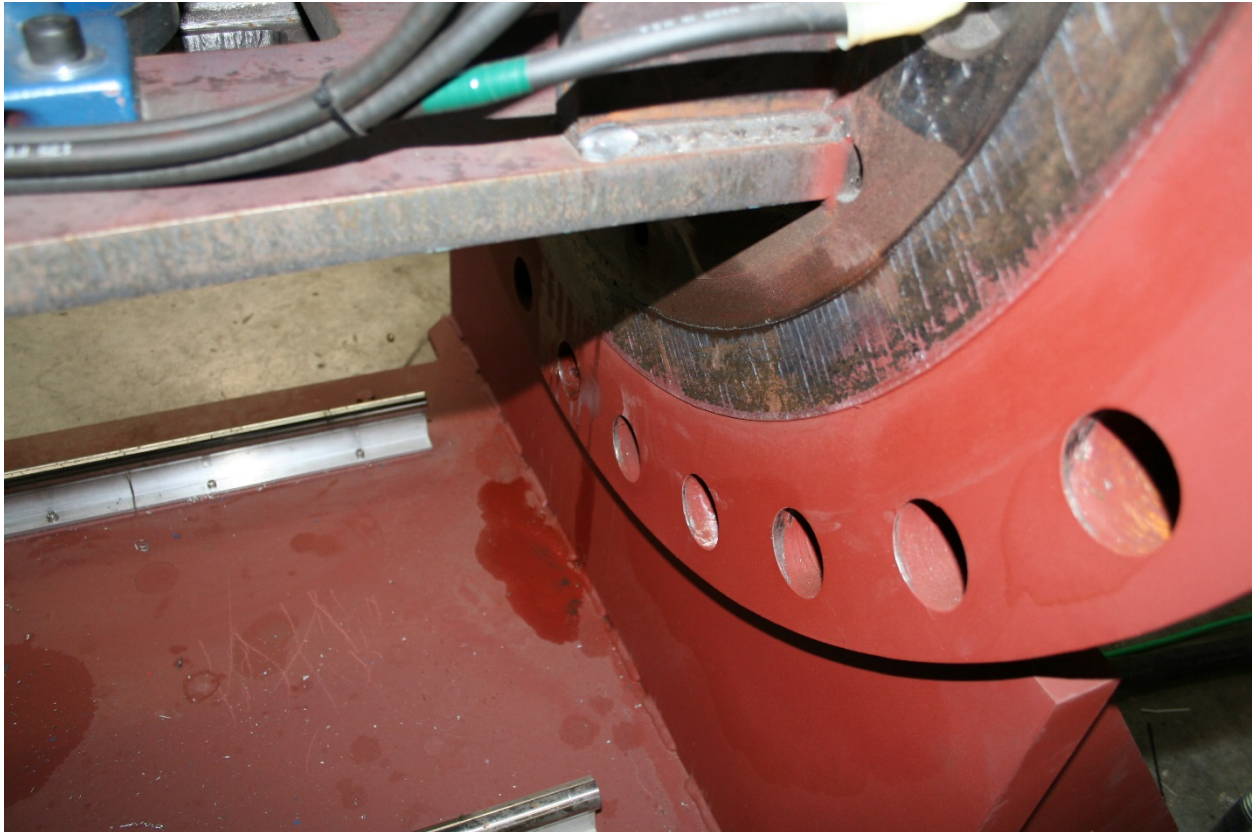
Figure 11. Oil on the vessel bulkhead, and dripping to the platform below after opening the tank.

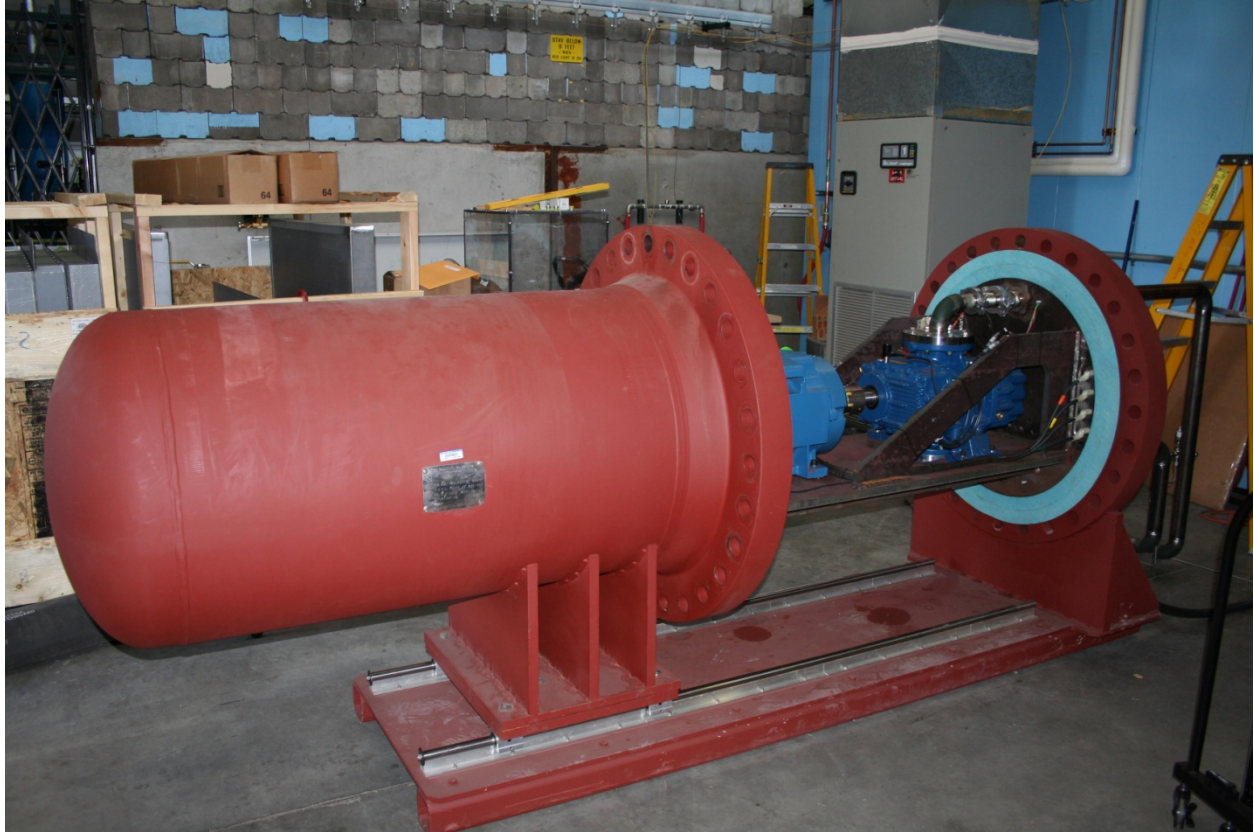
Figure A3. Vessel open, showing blower and motor.

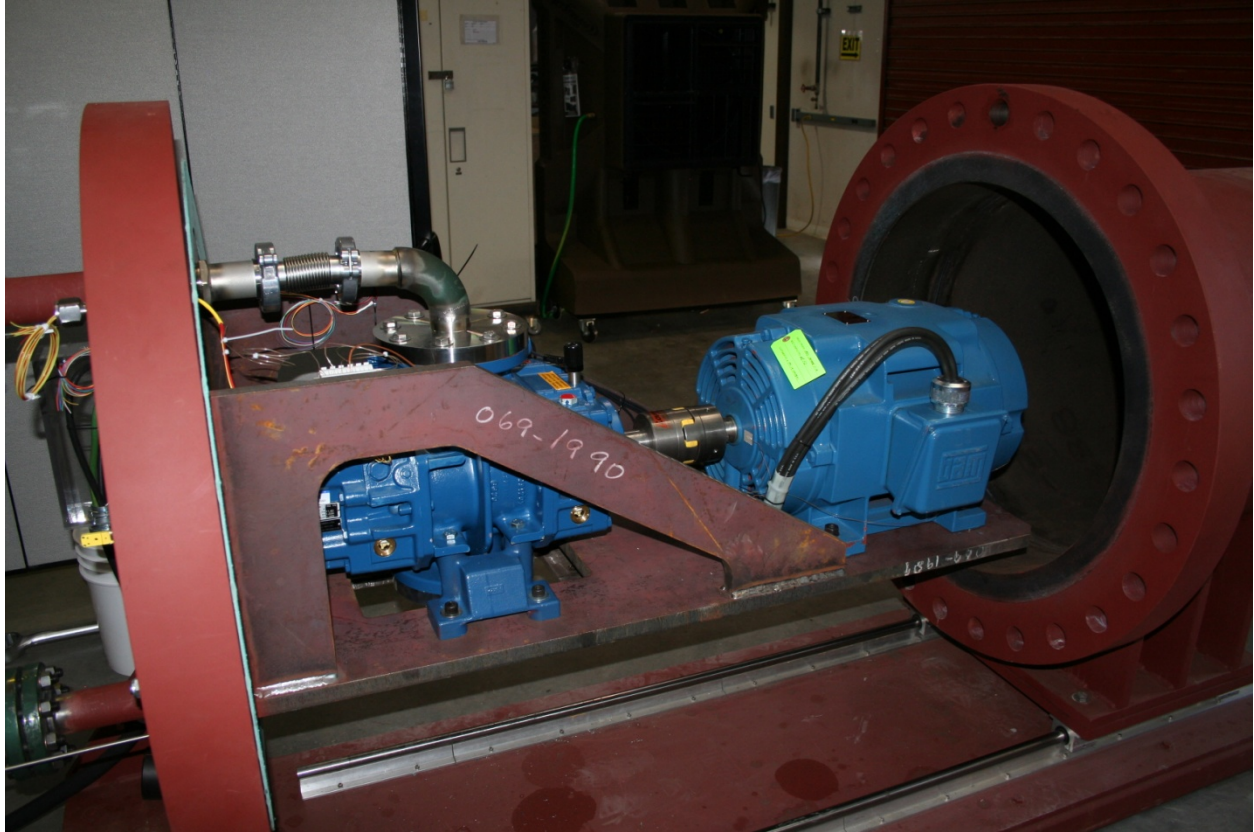
Figure A4. Close-up view of the blower, on the left, with motor. Motor is wired and blower exit piping is installed. (top left).

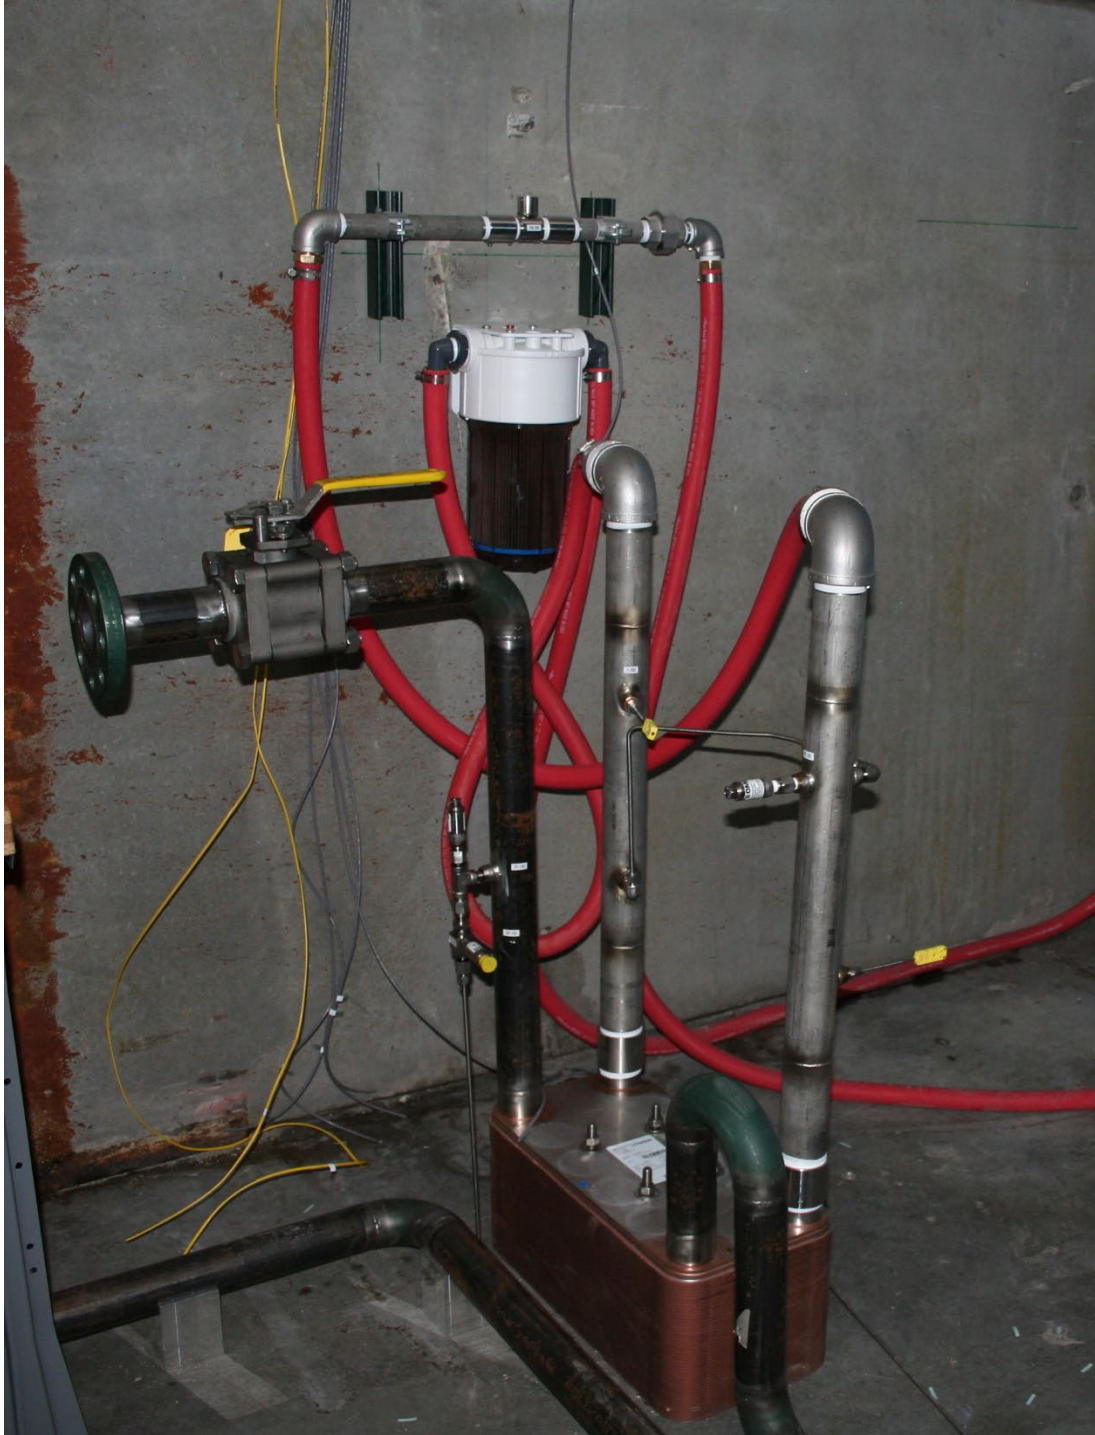
Figure A6. Heat exchanger (bottom of photo) along with piping and instruments. A water filter is mounted on the wall near the top.
